## **Reference 13**

**Falcon Refinery  
TXD 086 278 058**

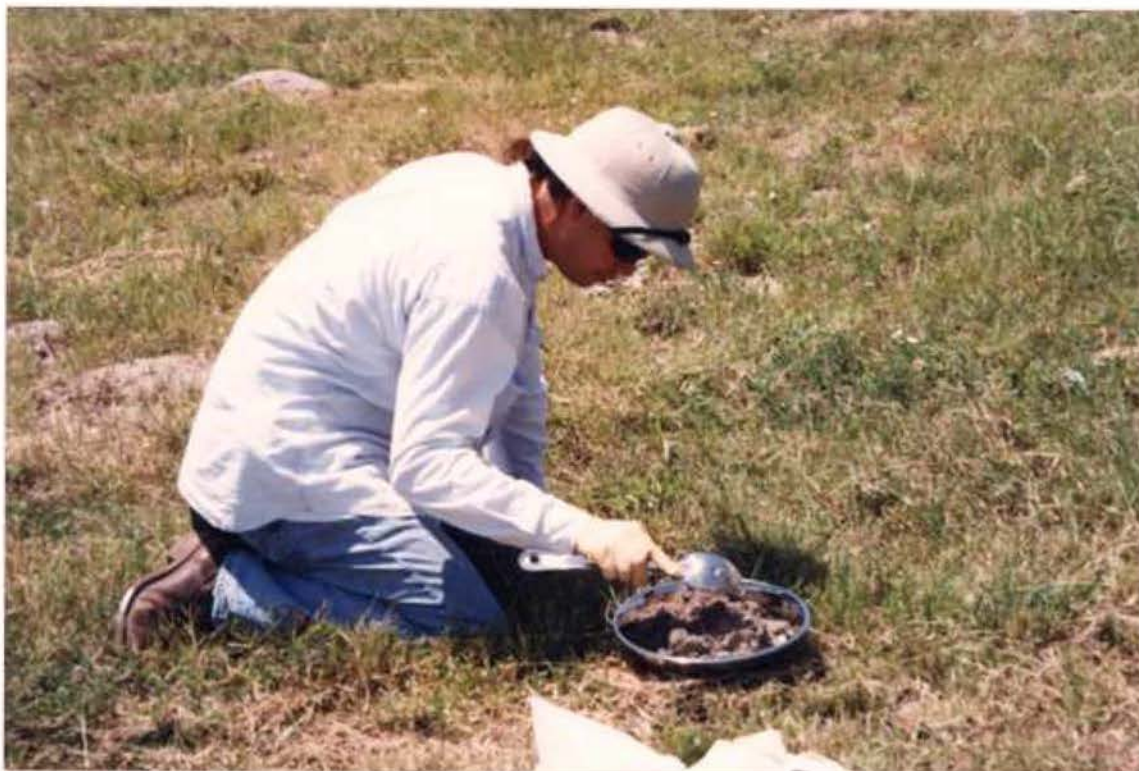
Roll #1 Photo 1 - 5/15/2000 Taken by: M.Cordell. Sampler: M.Cedilote. Collection of Sample SO-20 at Sassy's Pit Stop. Direction: West.

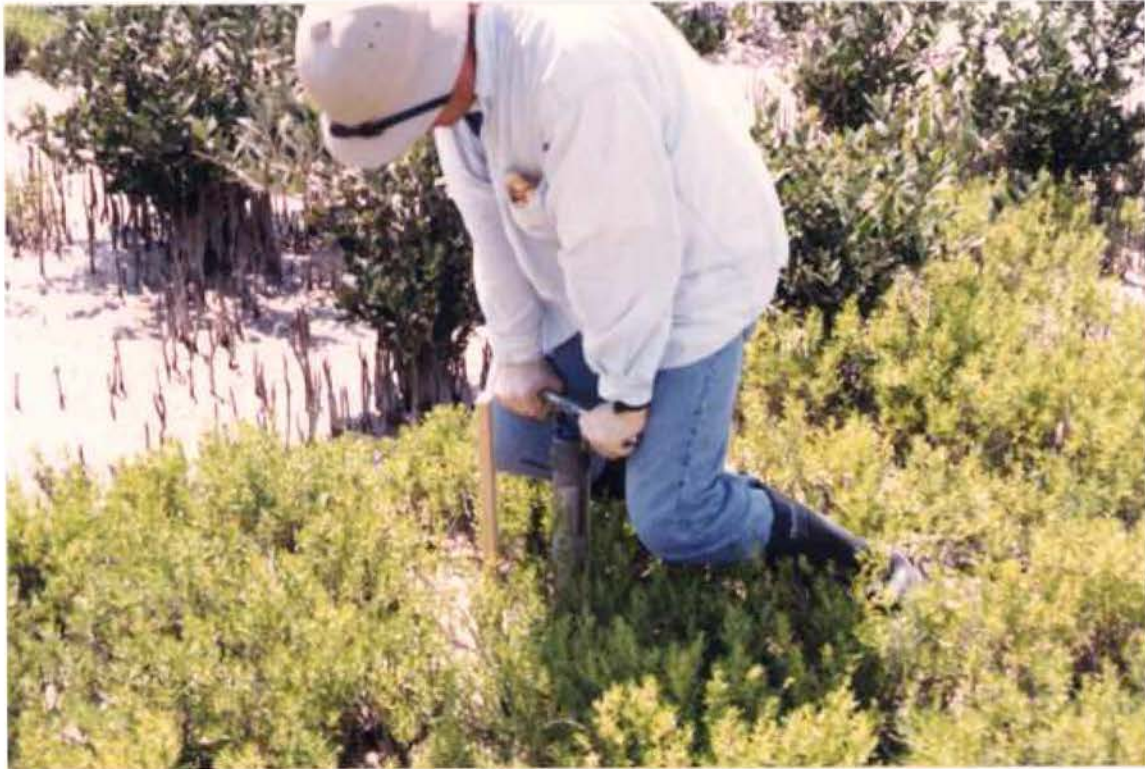
Roll #1 Photo 3 - 5/15/2000 Taken by: W. Newberry. Sampler: M.Cedilote. Collection of Sample SE-11 in wetland area near Alamo Concrete Products LTD. Direction: North.

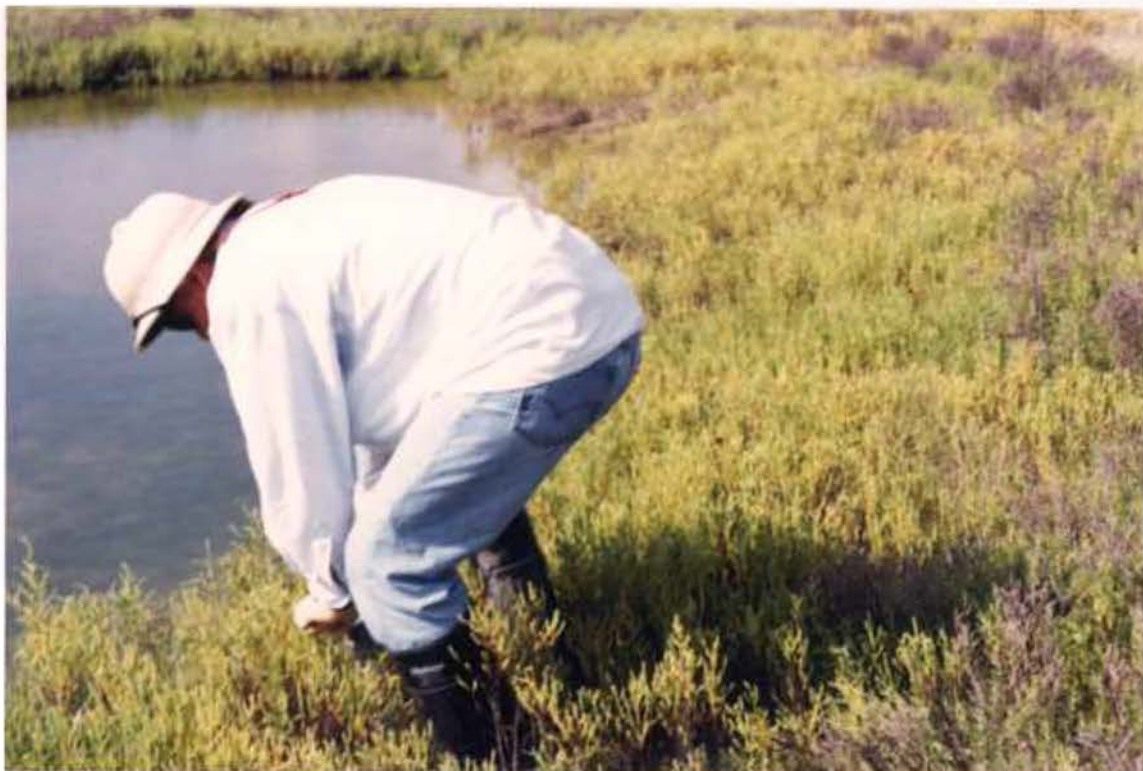
Roll #1 Photo 6 - 5/15/2000 Taken by: M.Cordell. Sampler: M.Cedilote. Collection of Sample SE-07 in HRS defined wetland area off the road near Aker Gulf Marine. Direction: North.

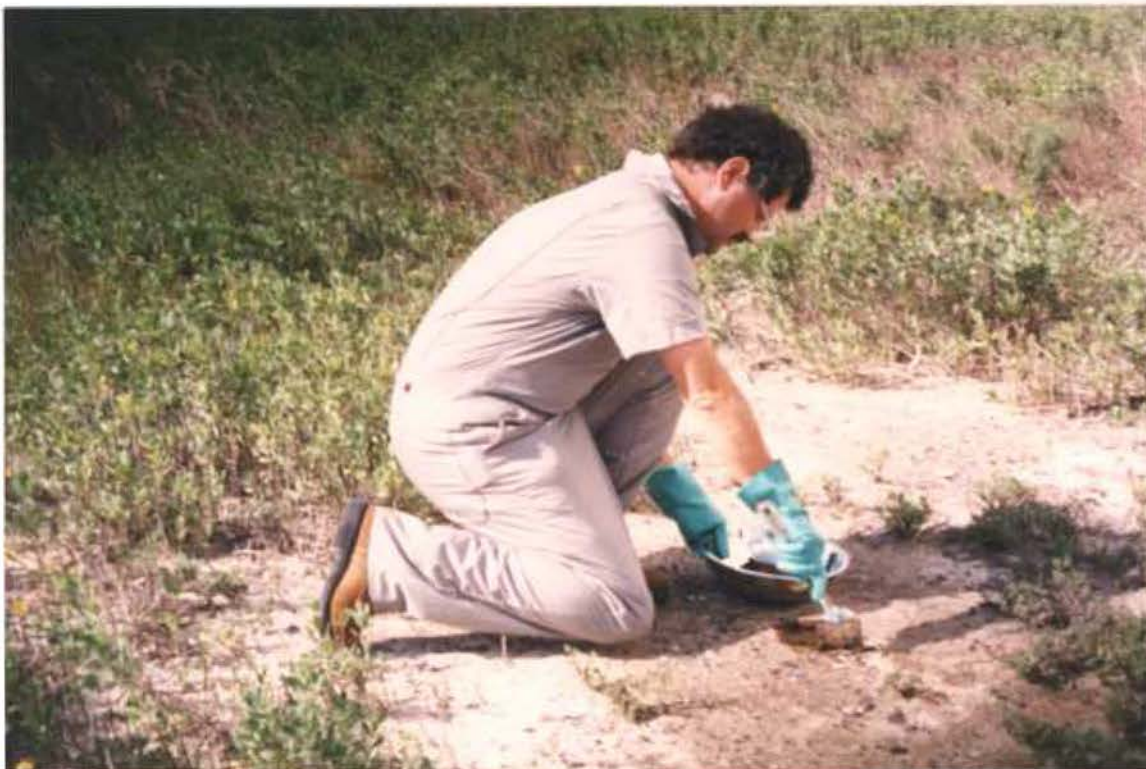
Roll #1 Photo 28 - 5/17/2000 Taken by: M.Cordell. Sampler: W. Newberry. Collection of Sample SO-15 by API separator and surface impoundment in drainage pathway to surface water and wetlands. Direction: North.

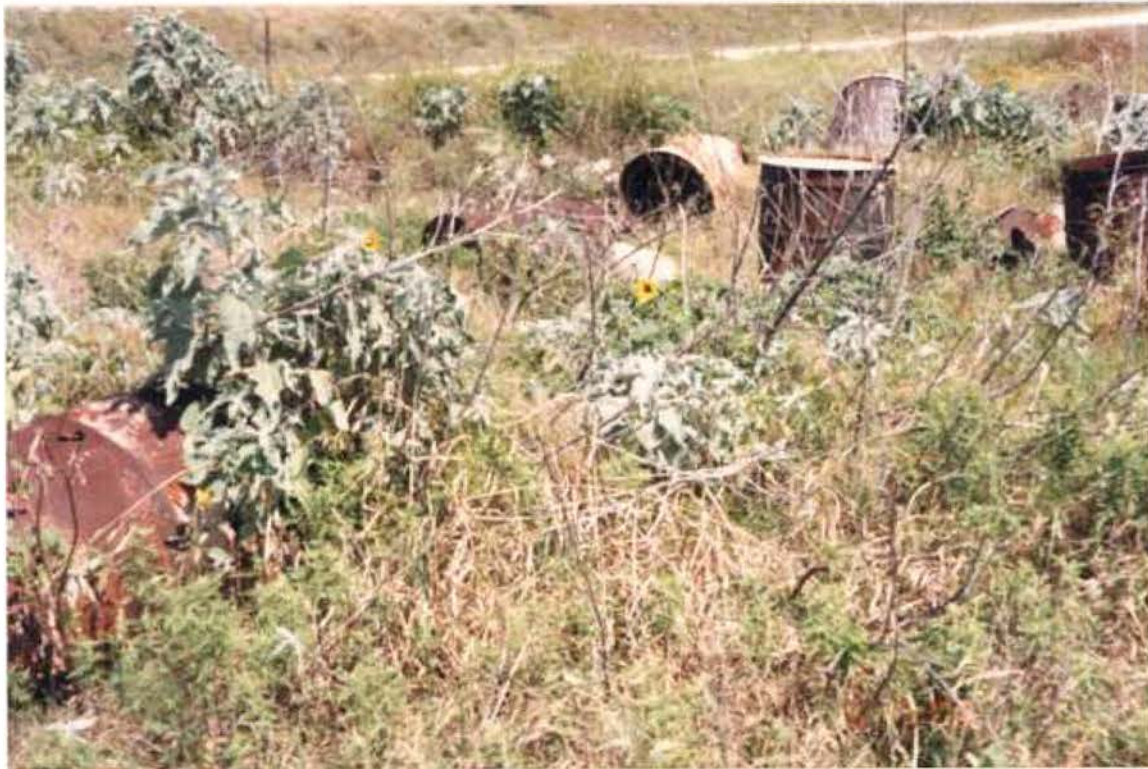
Roll #2 Photo 16 - 5/17/2000 Taken by: M.Cordell. Sampler: W. Newberry. Collection of Sample SO-19 near area of suspected leaking drums. Direction: East.

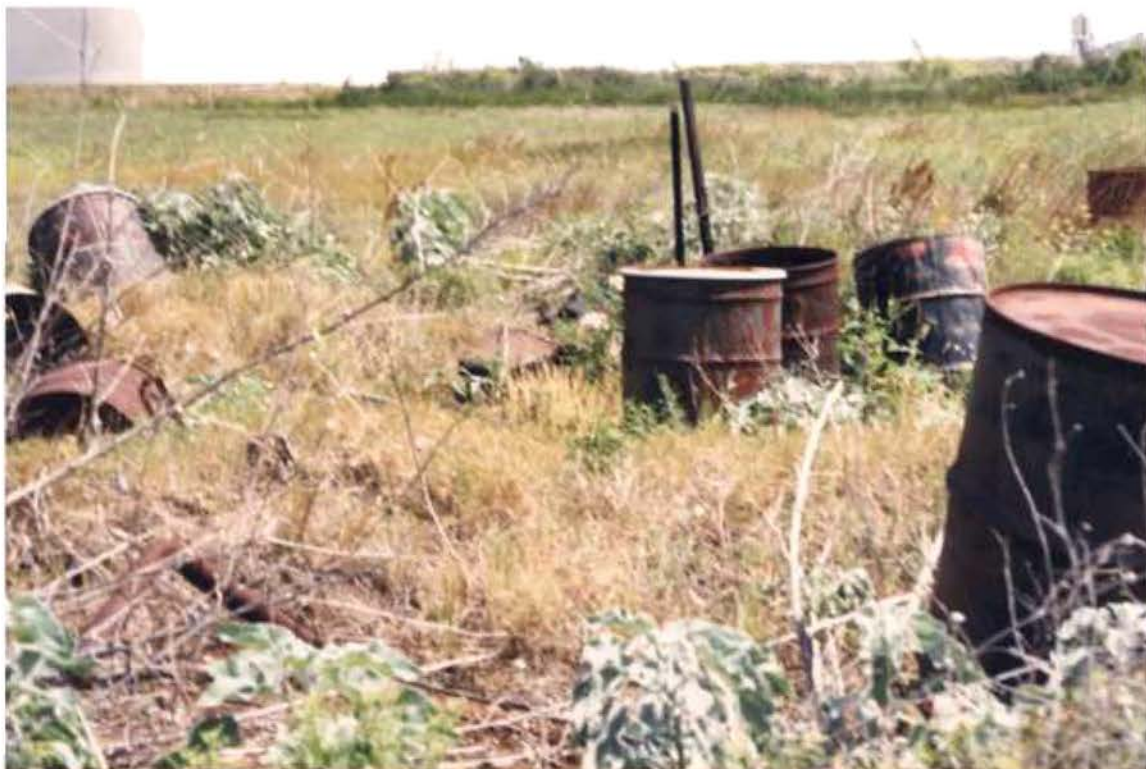
Roll #2 Photo 17 - 5/17/2000 Taken by: M.Cordell. Area of suspected leaking drums. Direction: Northeast.

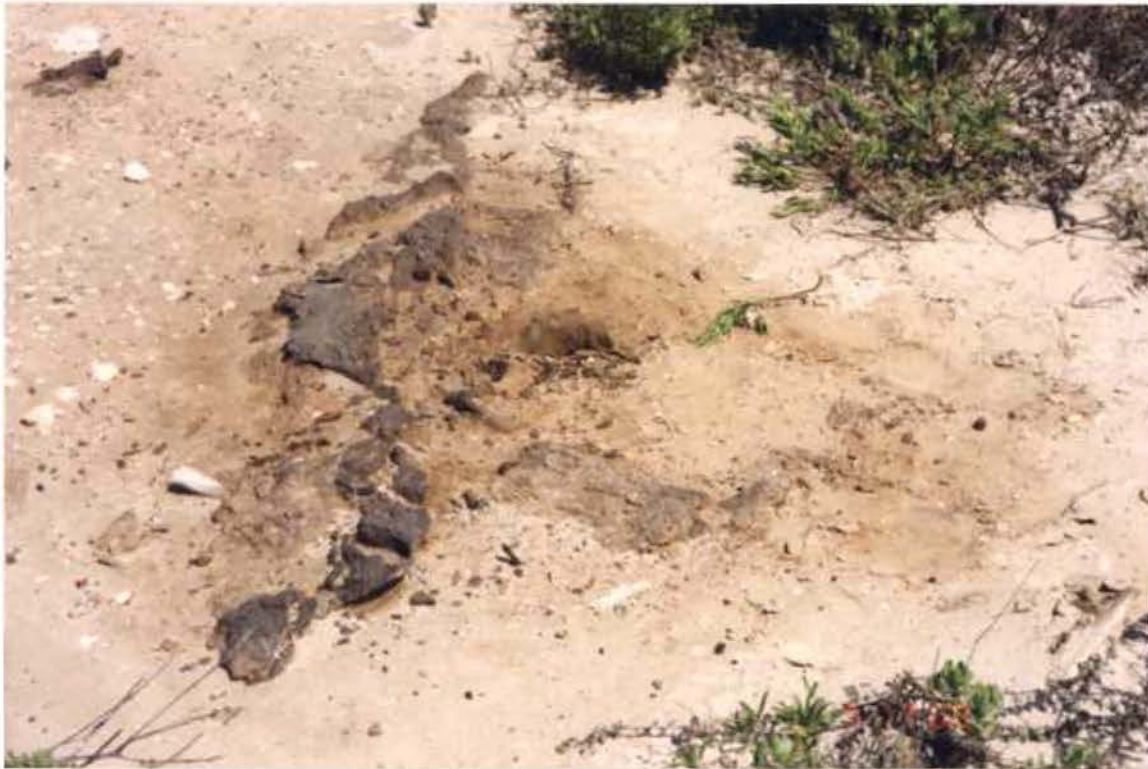
Roll #2 Photo 18 - 5/17/2000 Taken by: M.Cordell. Area of suspected leaking drums. Direction: Southeast.

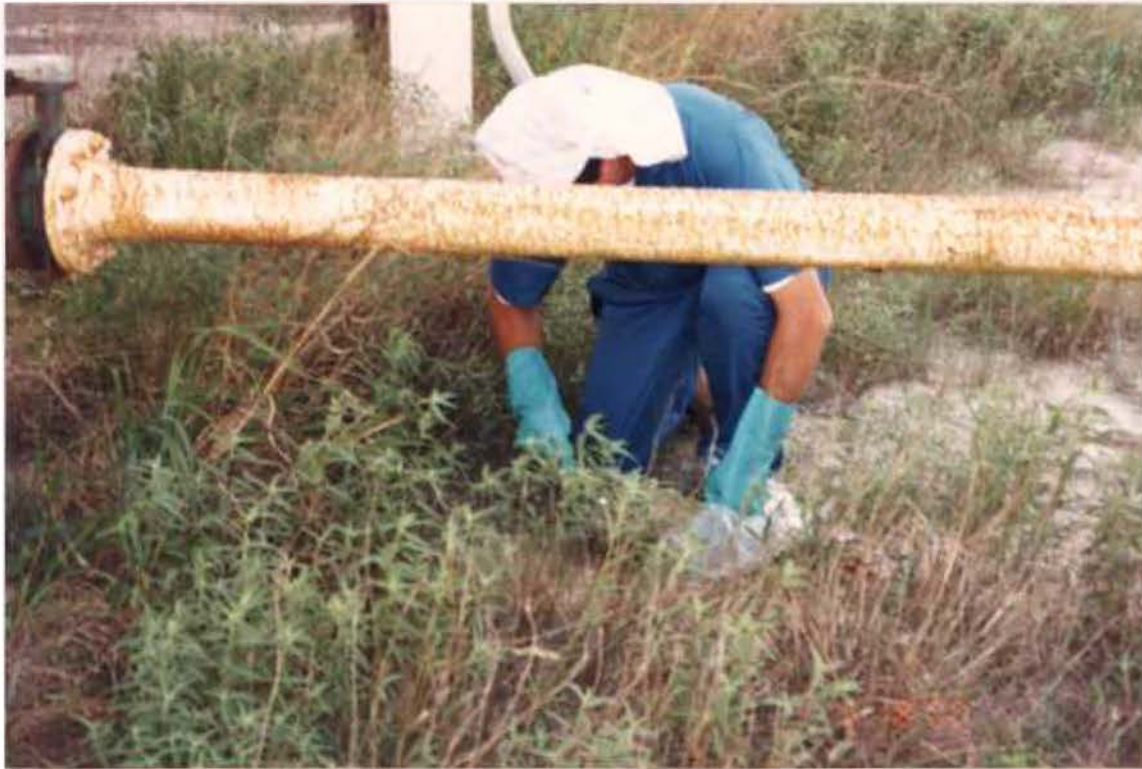
Roll #2 Photo 26 - 5/17/2000 Taken by: M.Cordell. Area of deteriorating drums, southwest of SO-28.  
Direction: South.

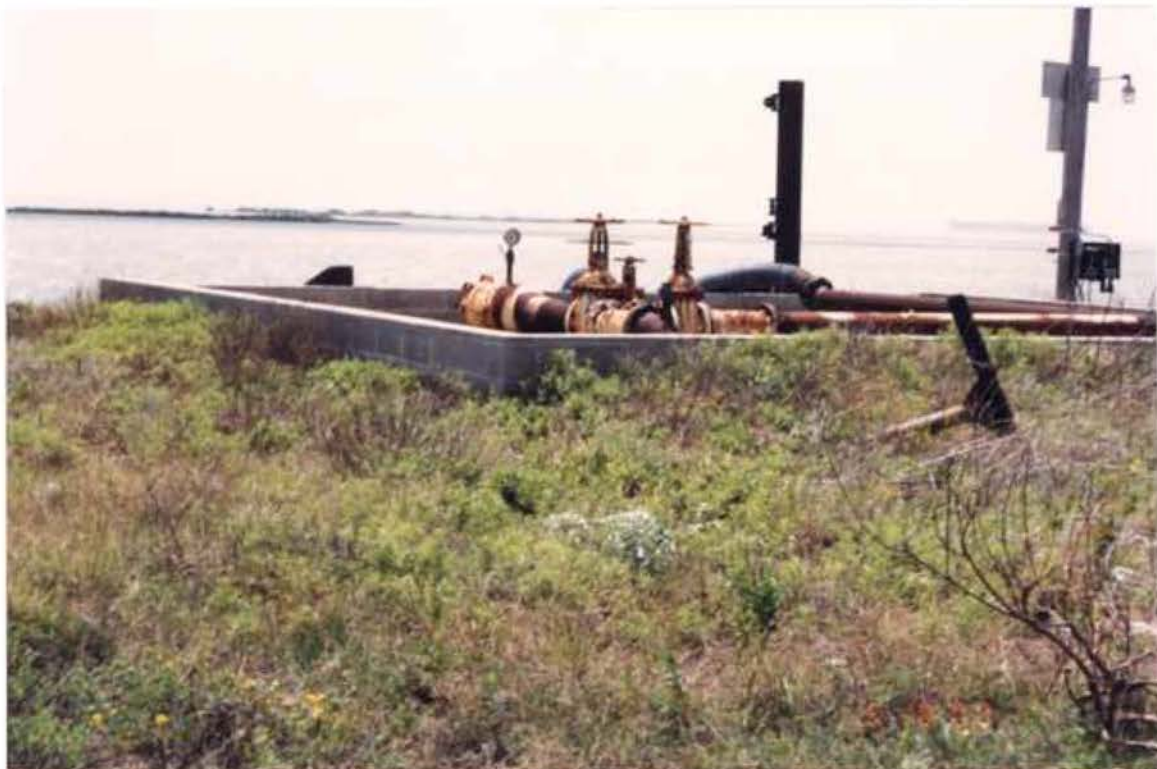
Roll #3 Photo 2 - 5/18/2000 Taken by: M.Cordell. Sampler: W. Newberry. From a location near SO-36, an aboveground storage tank is located on the NORCO property. Drainage appears to flow towards PPE<sub>3</sub> at Redfish Bay (SE-31). Direction: South.

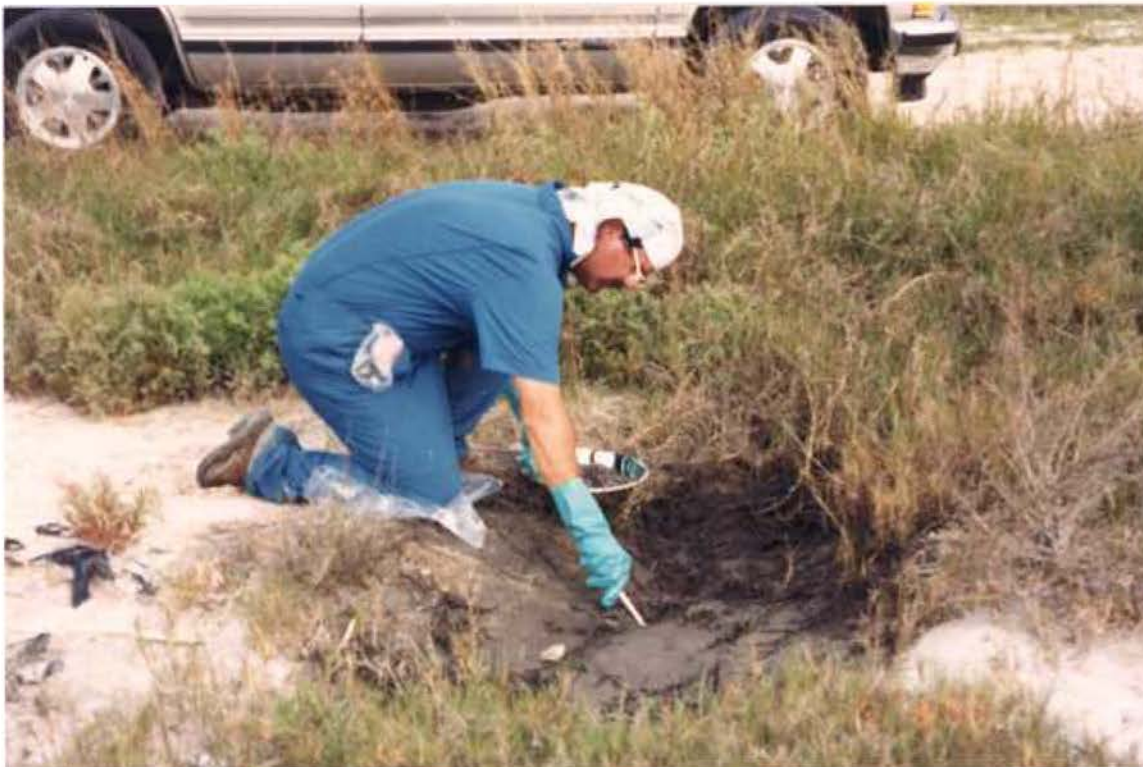
Roll #3 Photo 11 - 5/18/2000 Taken by: M. Cordell. Sampler: M. Cedilote. Collection of Sample SE-32 and SE-33 in wetlands near location of 1995 pipeline leak. Direction: West.

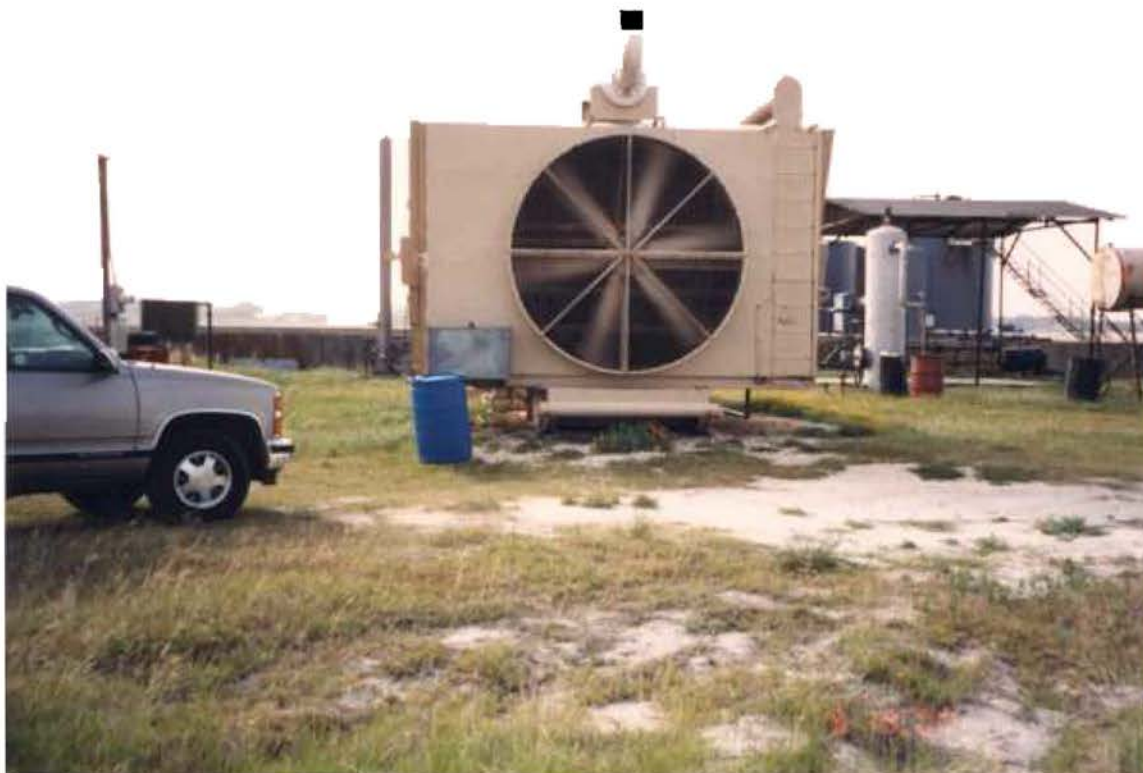
Roll #3 Photo 12 - 5/18/2000 Taken by: M. Cordell. Sampler: W. Newberry. Collection of Sample SO-06 near location of 1995 pipeline spill. Direction: East.

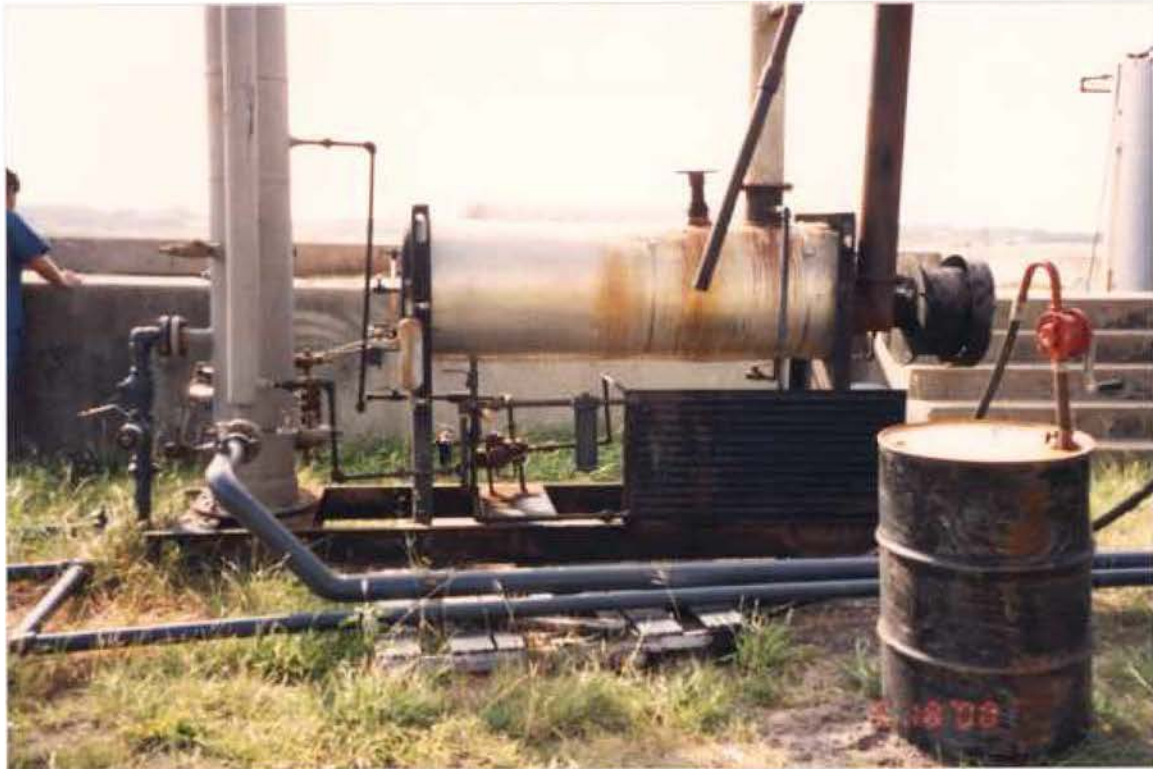
Roll #3 Photo 17 - 5/18/2000 Taken by: M. Cordell. Leaking liquid from equipment on IBC Petroleum property that appears to be connected to equipment on the Pi Energy property. Direction: Northwest.

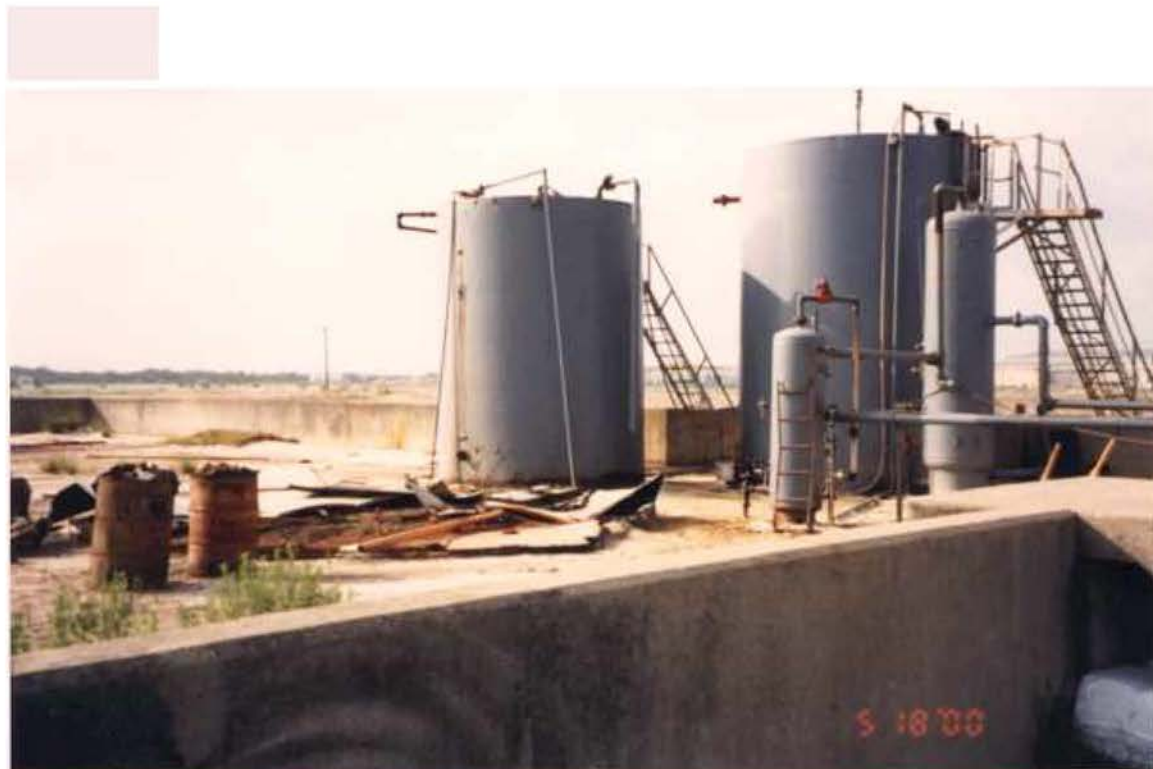
Roll #3 Photo 18 - 5/18/2000 Taken by: M. Cordell. Leaking equipment on IBC Petroleum property. Direction: Northwest.

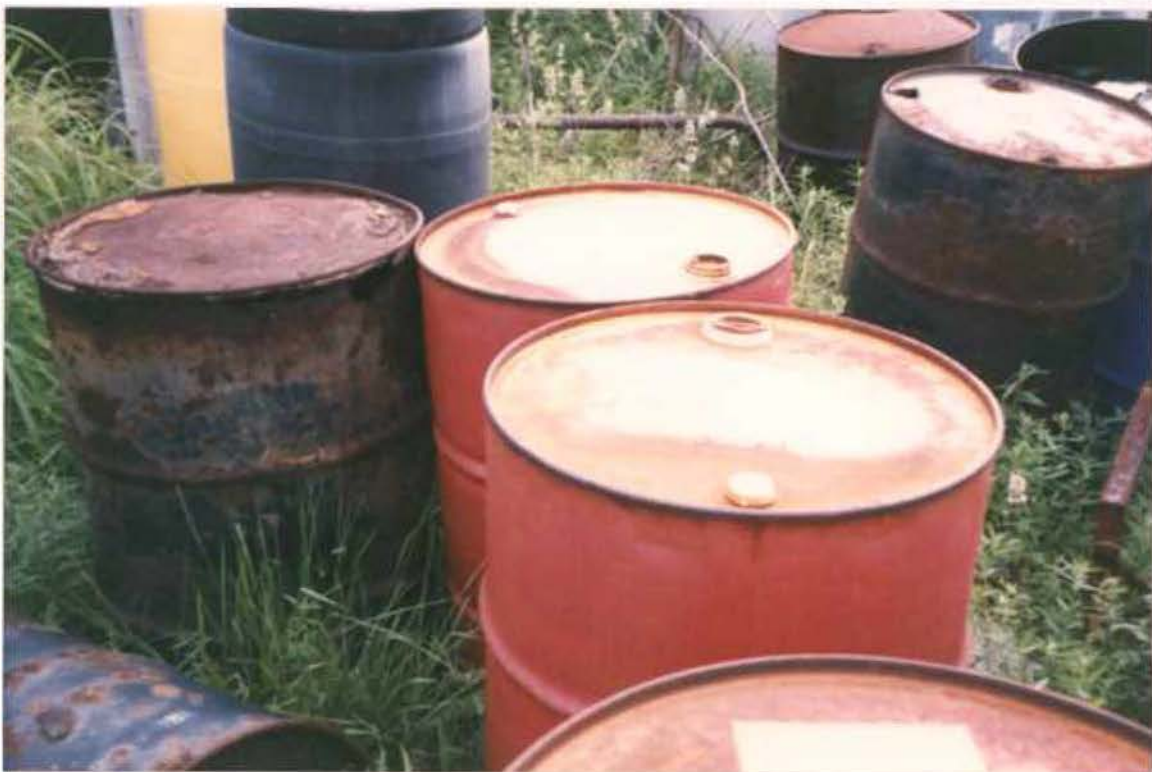
Roll #3 Photo 20 - 5/18/2000 Taken by: M. Cordell. Appearance of runoff of material on IBC Petroleum property. Direction: Southwest.

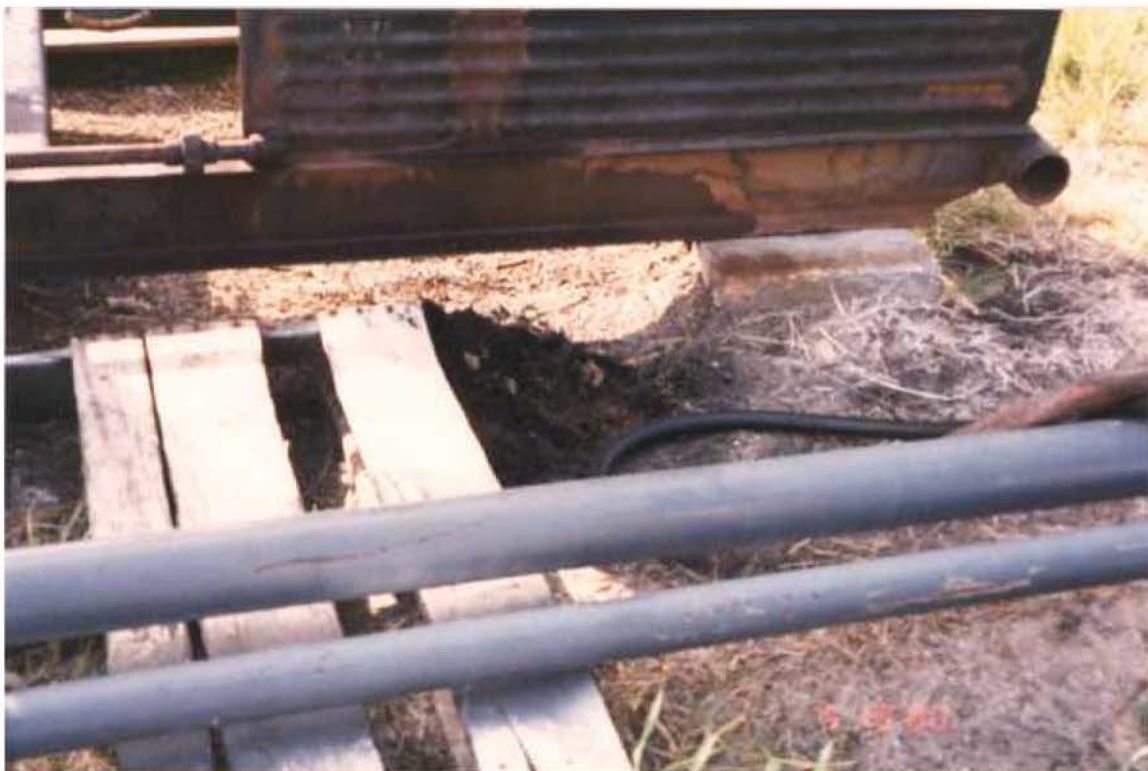
Roll #3 Photo 25 - 5/18/2000 Taken by: M. Cordell. Sampler: W. Newberry. Collection of Sample SO-05 from area of leaking equipment. Direction: Northwest.
